Manhole Inspection Summary

Manhole # S53Q__004MH

Insp Date: 11/5/08 1:09 PM

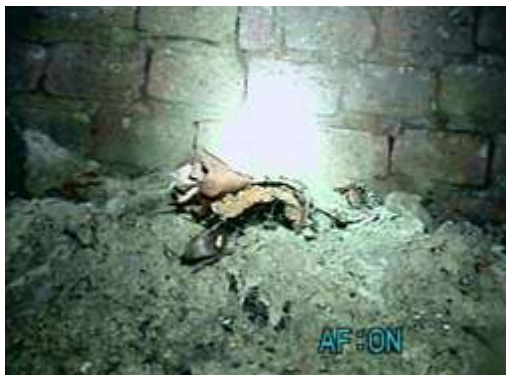
Defect 4

Condition: ☐ Sound ☐ Cracked ☐ Root Intrusion ☐ Deteriorated ☐ Leaks ☒ **Debris**

bench debris

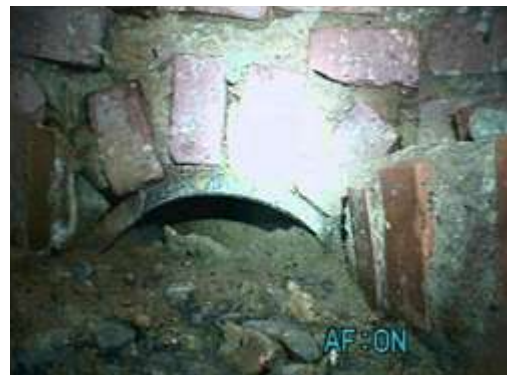
Defect 3

Condition: ☐ Sound ☐ Cracked ☐ Root Intrusion ☐ Deteriorated ☐ Leaks ☒ **Debris**

channel debris

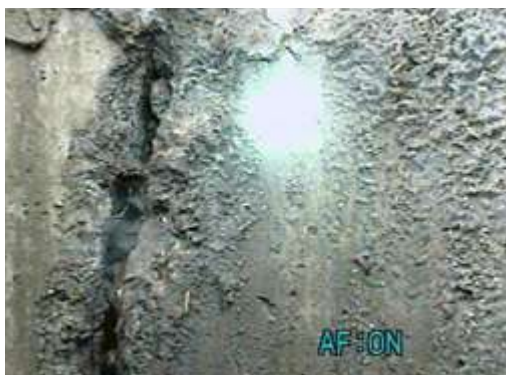
Defect 2

☒ **Leaks**

Condition: ☐ Sound ☒ **Cracked** ☐ Root Intrusion ☐ Loose Brick ☒ **Deteriorated**

Infiltration: ☐ None ☐ Joint ☒ **Cracks** ☐ Mortar ☐ Roots ☐ Wall

fracture in chimney/frame adj, chimney infiltration, frame infiltration

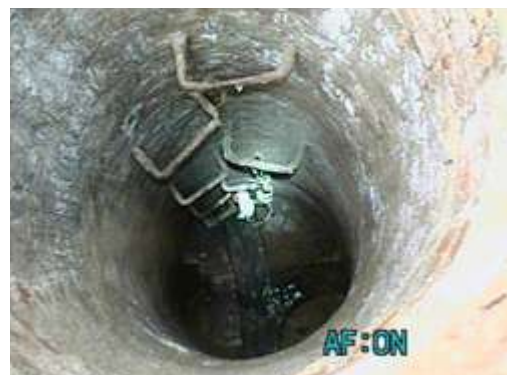
Defect 1

Count: **8** Missing: **0** ☒ **Corroded**

corroded steps, cracked and deteriorating chimney

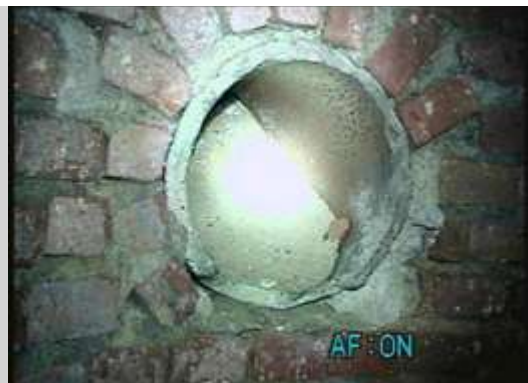
9 O'Clock Inflow

Deposits: ☐ None ☐ Mud ☐ Sludge ☒ **Debris** ☐ Grease

Silt Depth: **7** (in.) Deposits Extent: **Heavy**

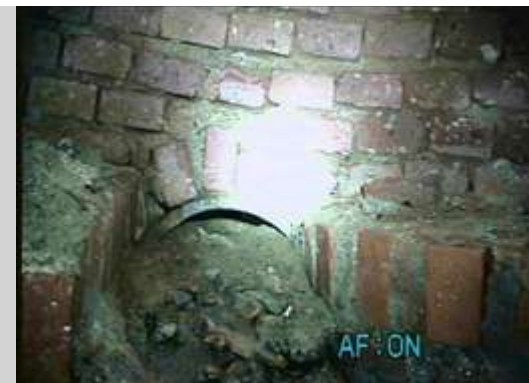
Drop In @ 9 OClock

Drop: **Outside** **Direct**

Drop Condition: **Partly Clogged**
